Installation Manual

Woolworths ItabAlphagate Kit 4 manual

The aim of kit 4 and associated manual is to convert a phase 2 welcome gate assembly to a new type kit 8 (stockloss) assembly with new lead in rails and bumper rail kit. Before commencing work onsite please see drawings and images below. Please take note that the existing phase2 gate assembly and associated rails will need to be integrated into the components of kit 4 to complete the installation.

Woolworths Kit 8 (Stockloss) Itab autogate installation and commissioning Manual

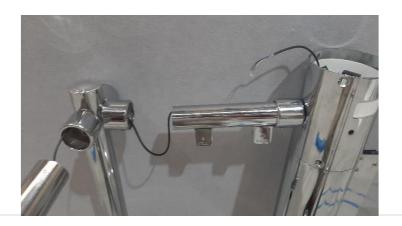
Please take note of internal cabling route within existing phase 2 welcome gate assembly. These cables run from the top of the gate bollard to the front upright post. Where uprights, rails and or gate bollards meet has the potential for these cables to be damaged while gate assembly is being disassembled.

RED LINE REPRESENTS INTERNAL PEC SENSORE ROUTING

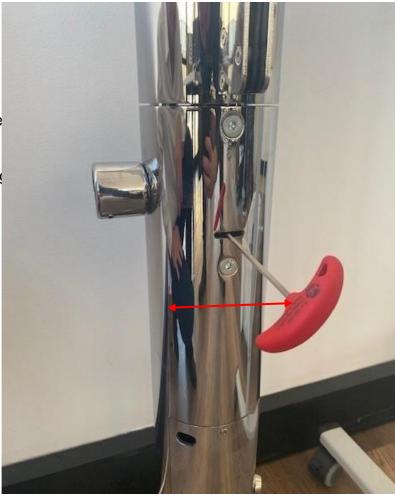
- b. If the gate arm needs to be adjusted for alignment, providing you are sure there are no sensors in circuit, loosen the locking screw that holds the coulisse (electronic encoder circuit/position sensor as shown in the image below) with 3mm Allen key and move the coulisse a little bit to the left or to the right depending on how the gate arm needs to be adjusted.

Move Allen Key to the right gate arm moves to the le

Move Allen Key to the left gate arm moves to the right

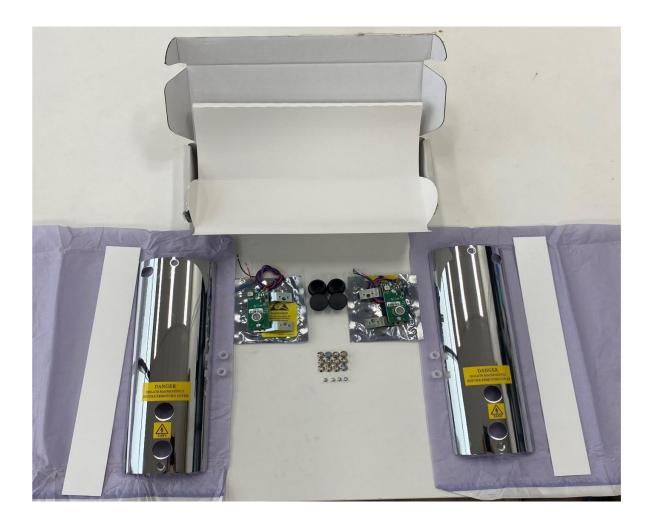
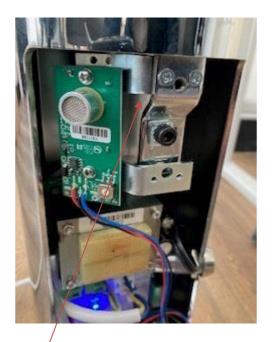
In some circumstances CSS kits may be supplied separately and will require onsite fitting – see kit contents and installation position images below.

Note there are left and right-hand fixing brackets for individual gate bollards.

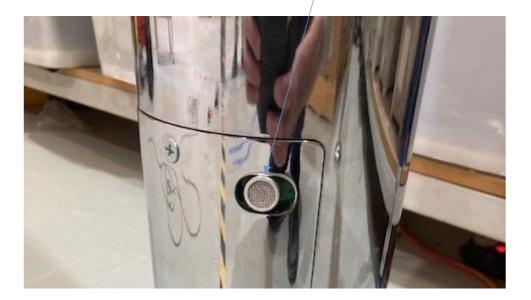
Important: the front cover metal case should <u>**not-touch**</u> the metal casing of the sensor assembly (see below image) – if adjustment needed, gently bend the fixing bracket with pliers as required.

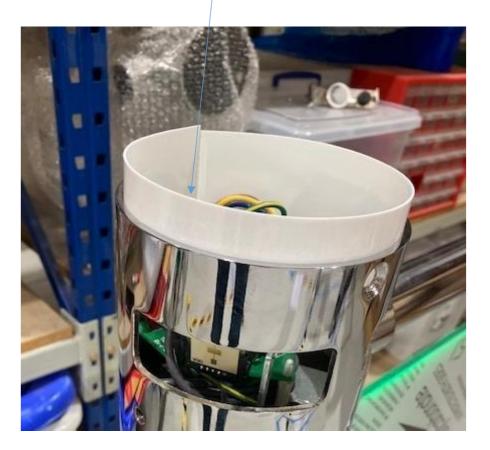
9. Fit new type radar sensor cover-strip (if supplied) before CSS commissioning commencem

(Radar cover slides in & out without fixings cover to join to the side away from gate bollard cut out)

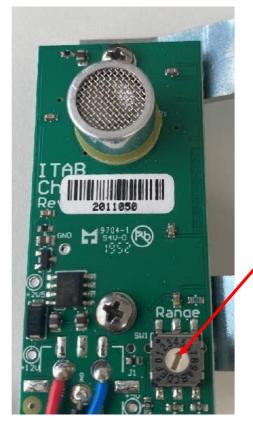
Setting	Rang e (cm)
0	75
1	80
2	85
3	90
4	95
5	100
6	105
7	110
8	115
9	120
A	125
В	130
С	135
D	140
E	145
F	150

Select setting **#5** initially to match the 1000mm arms & adjust up or down as required. (See checklist for testing instructions and adjust to comply if required)
